The Marin County Flood Control and Water Conservation District (Zone 4) completed the revegetation component of the Saltworks Canal Biotechnical Bank Stabilization Project in November 2007. Saltworks Canal is located in the unincorporated community of Strawberry Circle adjacent to Tiburon Boulevard (State Highway 131).

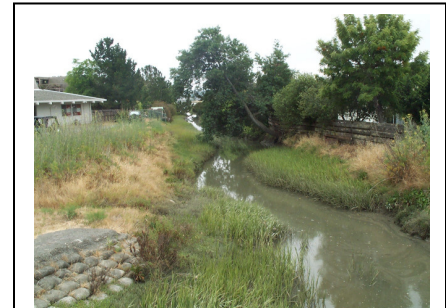
Pre-Project

The west bank of Saltworks Canal was severely eroded by tidal currents that resulted in the loss of property and the toppling of backyard fences.

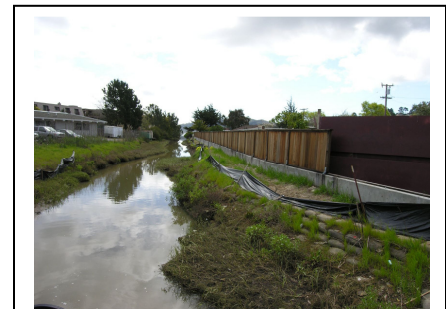
Post-Flood Wall

The early phases of the program included the construction of interior drainage, a pump station, and a seawall.

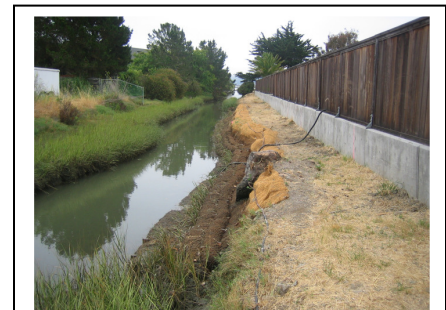
Post-Coir Log Installation

In June 2007, the Flood Control District used a biotechnical bank stabilization technique to stabilize and enhance the bank. They installed coconut fiber logs and gabions and native vegetation (cord grass and salt grass) along linear sites adjacent the seawall. The coir logs/gabions will provide a stable structure for root growth. As the logs decompose over time deep-rooted vegetation will establish to act as a self maintaining erosion control system.

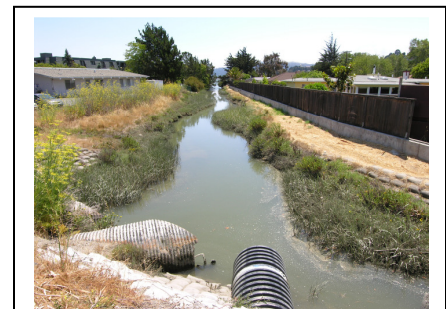
Post-Project

In November 2007, native woody plant species were planted (coyote bush and toyon) to further stabilize the upper portions of the bank. The final phase of the project will be to install an emergency backup generator for the pump station.
